# Evaluation of the Broumov parish house failure, its causality, and some ideas of remediation

*Structural Analysis of Monuments and Historical Constructions (SAHC) Master's Thesis*

*Czech Technical University in Prague*

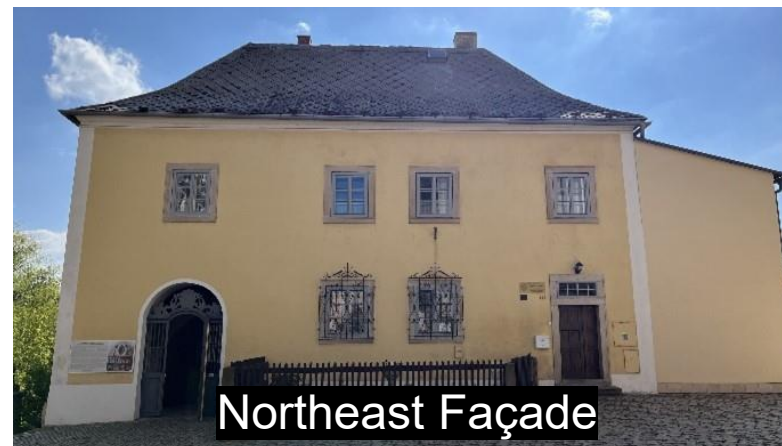
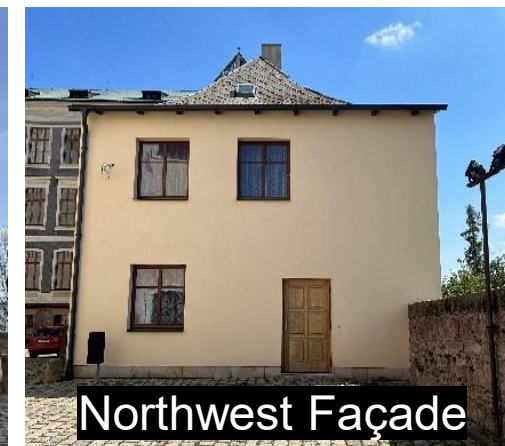
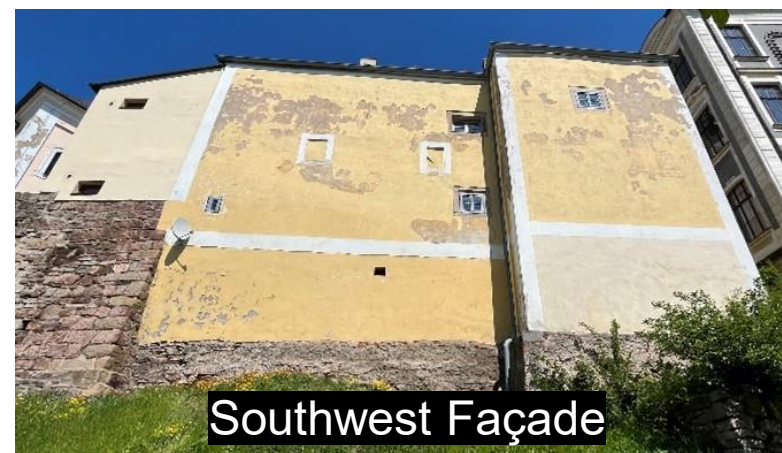
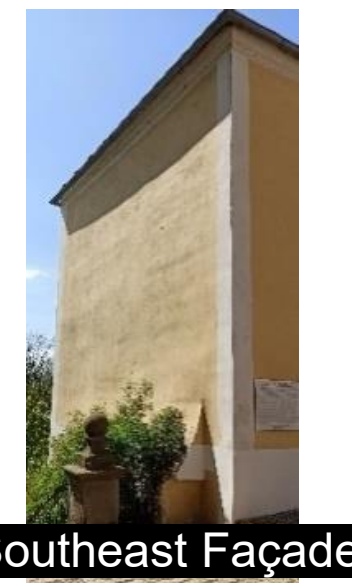
The decay is **limited** to the superficial layer of **plaster** and has **not affected** the underlying **structural elements**.

- ***Crack monitoring and testing:***
  - electronic **crack monitors**.
  - crack endoscopy tests for the nature and severity of the cracks.
- ***Soil monitoring***, after investigating its mechanical parameters and the existence of foundation
- ***Moisture detection and evaluation*** using thermal cameras.
- ***Roof's condition evaluation:***
  - **leak tests** to identify areas where water penetration might occur.
  - the **main elements** should be **tested** to ensure the stability of the structure.
- ***Further investigation of the fresco's room condition:***
  - **cracks** on the ceiling and corners of the room.
  - thoroughly **test** the fresco room for **moisture**.
- The most immediate action that can take place promptly is the ***re-plastering of the exterior walls***.

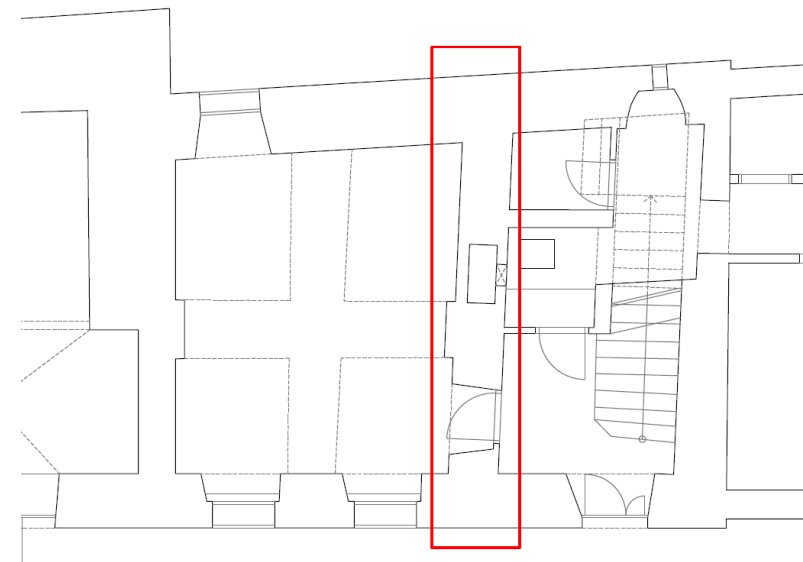
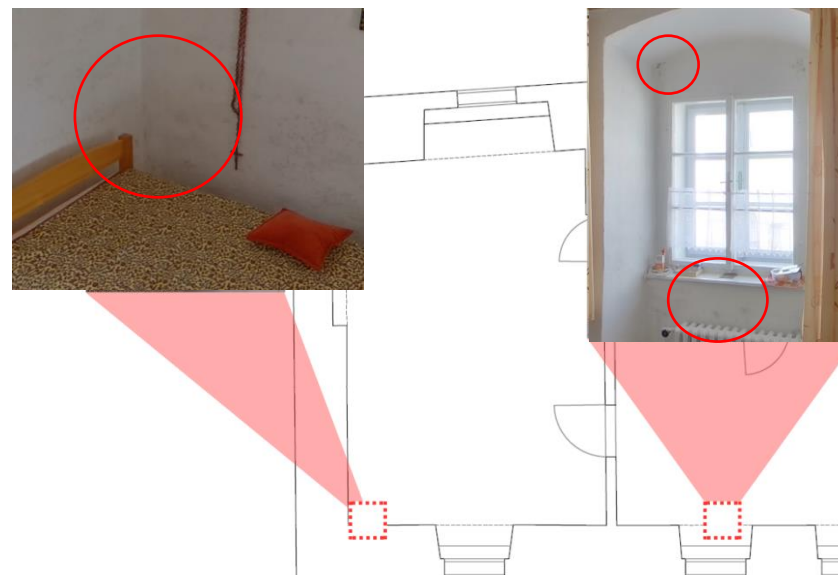
- Fractures along the walls of most rooms, especially the middle wall of the main section.
  - Potential cause → ground deformations.
- Extensive moisture on the first floor.
  - Potential cause → roof problems.

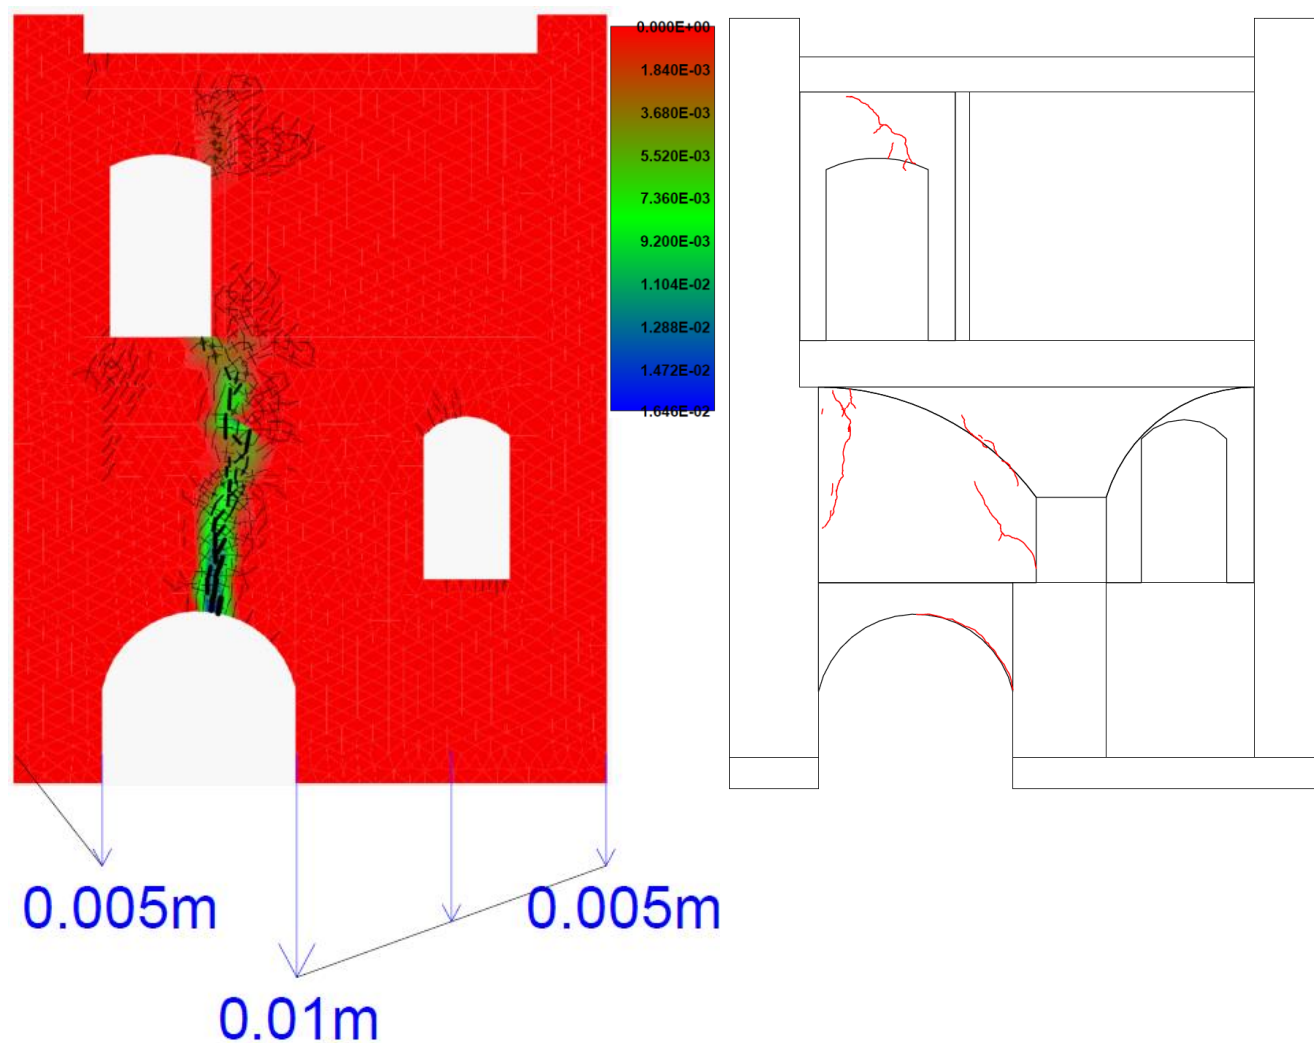
# 1<sup>st</sup> Hypothesis - Ground Settlement

- Displacement → linear distribution.
- Basement highest value → visual inspection.

- Pattern → similar.
- Width:
  - Crack above the basement vault width > 1 cm.
  - The rest widths' < 1 mm => cannot be visibly noticeable, which is not the reality.

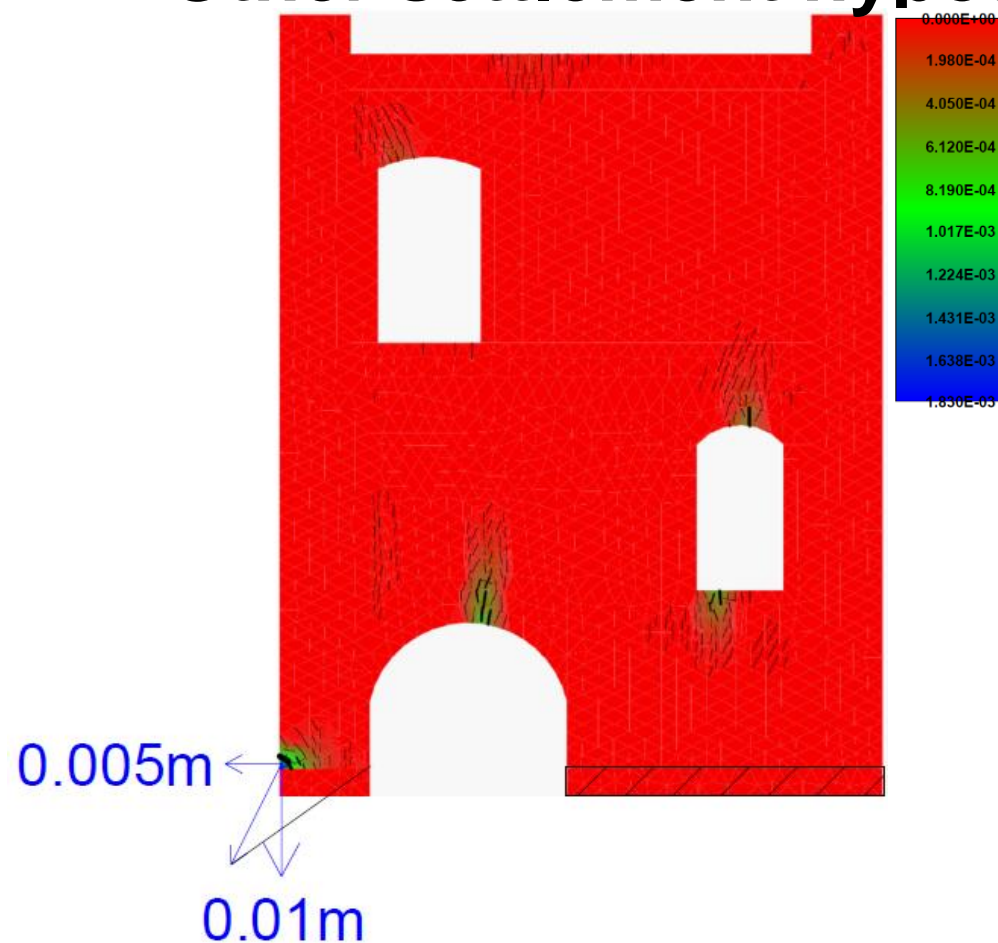
- **Settlement of the left wall** assumed that the city wall might give in to the weight of the building.

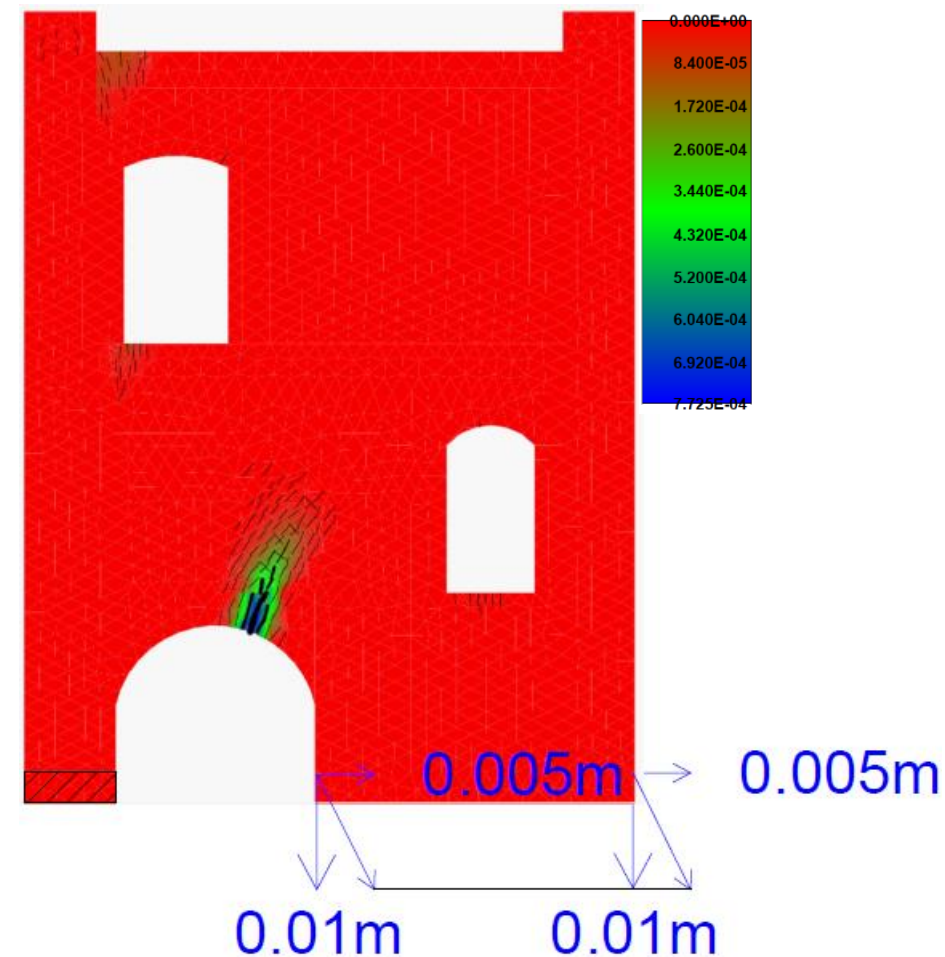
- **Settlement of the right part of the building**, assumed that the settlement is concentrated beneath the building.

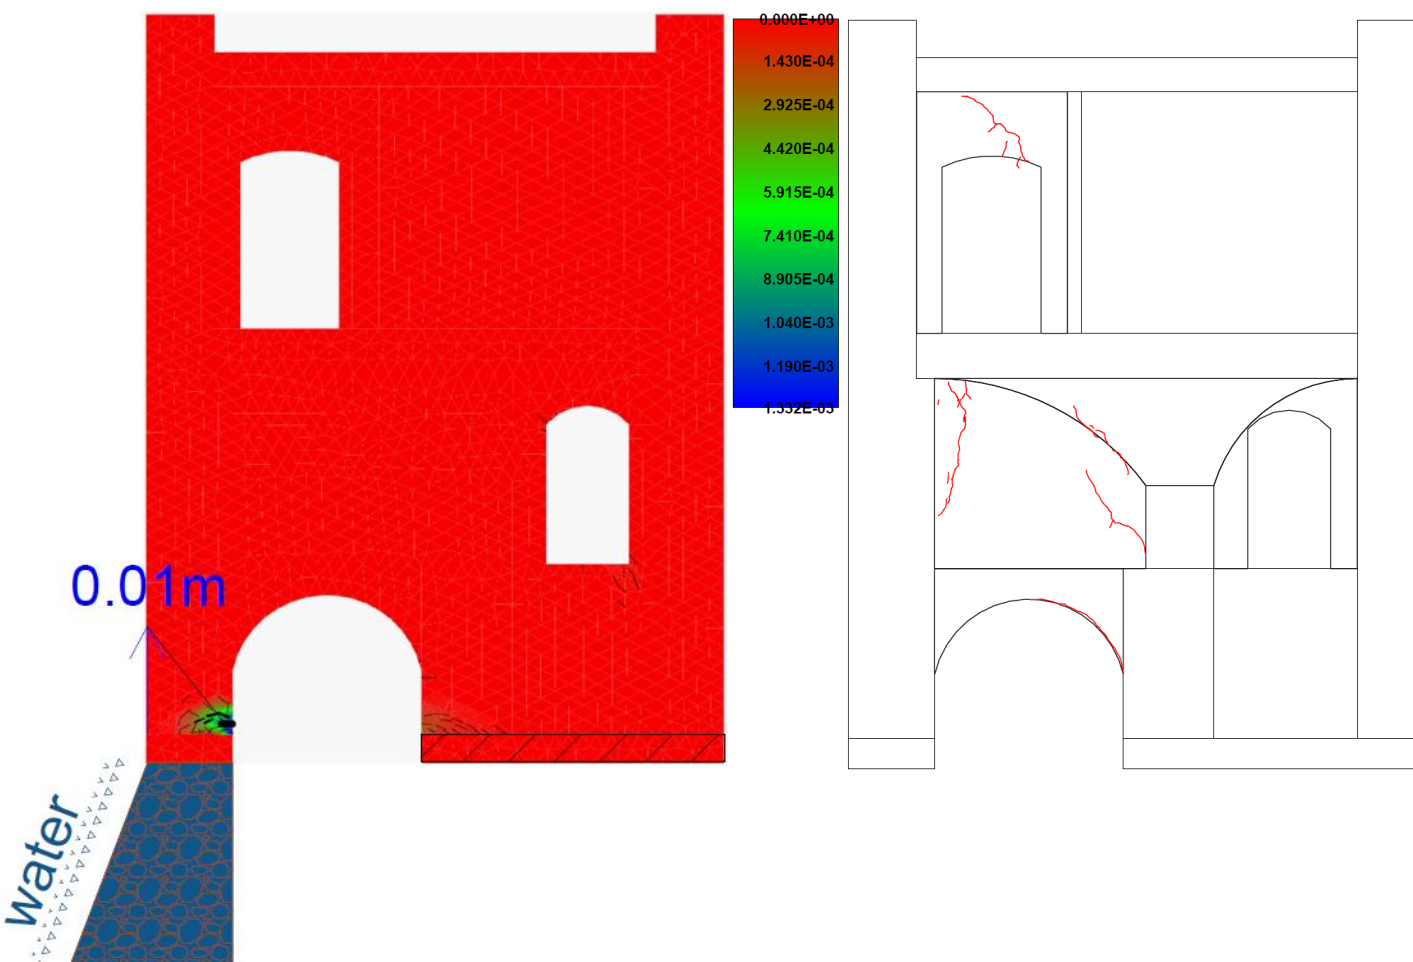
## 2<sup>nd</sup> Hypothesis - Freeze-thaw cycle

- more vulnerable to water infiltration.
- easier affected by the freeze-thaw cycle.

- Not aligning
- The results could be significantly different if the real data were utilized.

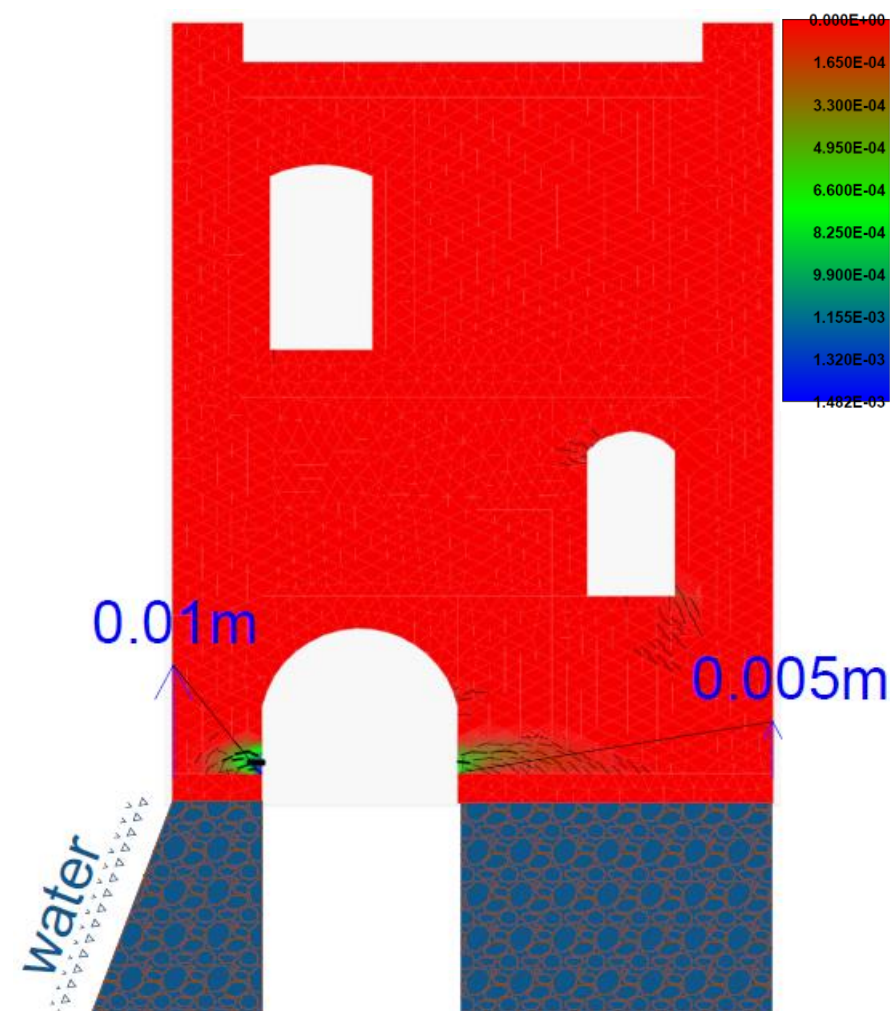
- **Expansion of both exterior walls**, considering that the foundation beneath the right wall does not directly interact with the environment, it was assumed that the displacement beneath the right wall would be smaller.
