ADVANCED MASTERS IN STRUCTURAL ANALYSIS OF MONUMENTS AND HISTORICAL CONSTRUCTIONS

Master 's Thesis

Evaluation of the Broumov parish house failure, its casualty, and some ideas of remedation

University of Minho

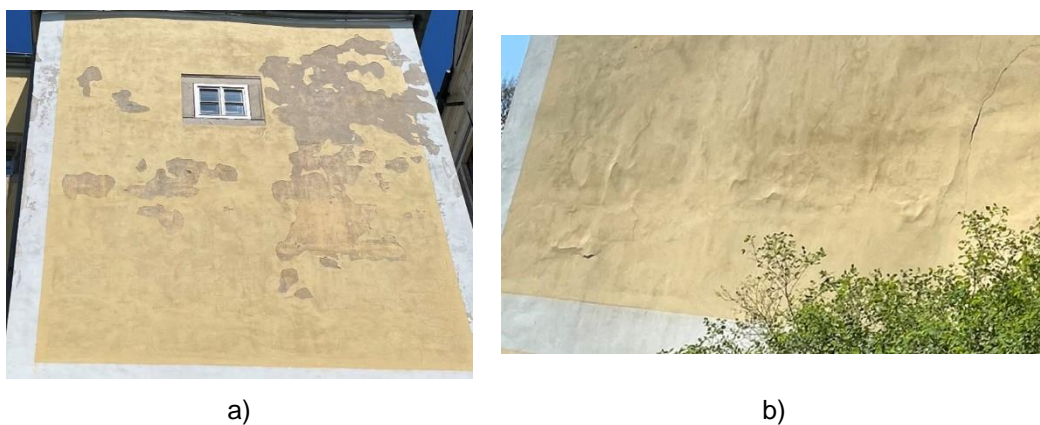
According to ICOMOS guidelines, detachment encompasses various manifestations such as blistering, bursting, delamination, disintegration, fragmentation, peeling, and scaling. In the case of the building's façades, specific issues observed include blistering, delamination, and peeling. Among the façades, the southwest side exhibits the highest level of decay, with large sections of missing plaster. The southeast façade displays widespread blistering issues across its entire surface. On the other hand, the northeast and northwest façades demonstrate no significant detachment problems, apart from minor instances near the area adjacent to the small garden on the main façade.

Figure 4.3 - a) Delamination of Southwest facade, b) Blistering of Southeast facade

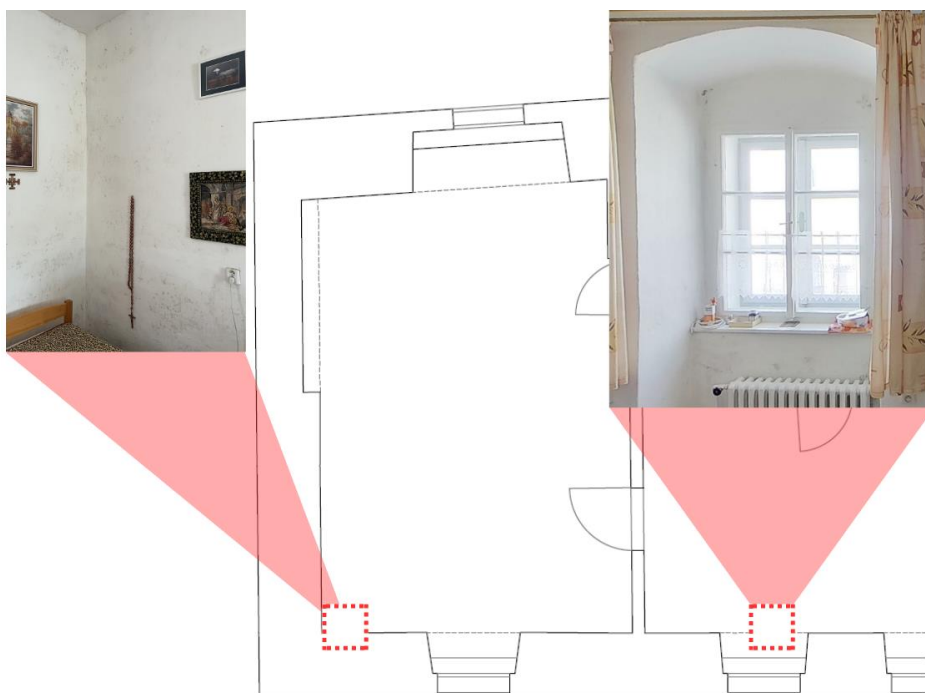
The second prominent form of decay is the extensive moisture observed primarily on the first floor, particularly in the bedroom and the kitchen areas. The presence of significant moisture infiltration poses a significant concern, as it can contribute to the deterioration of building materials, promoting the growth of mold and mildew. The most possible reason for the existence of moisture is problems on the roof of the building, which was inaccessible for further investigation.

Figure 4.9 - Moisture on the walls of the first floor

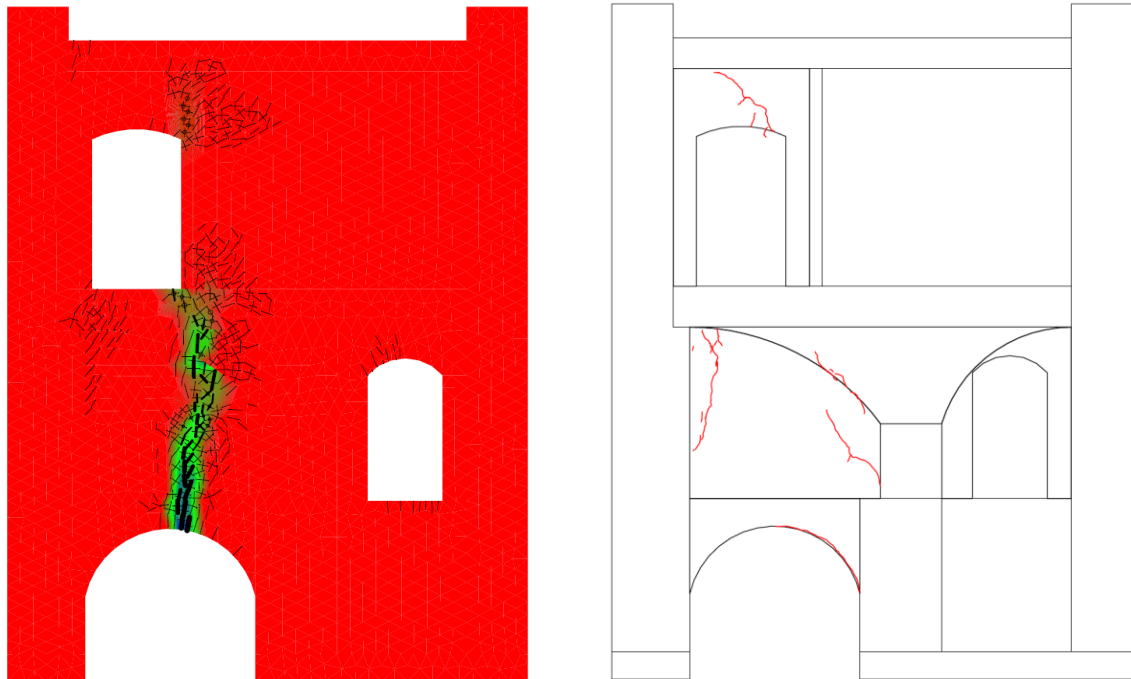
Figure 6.20 - Comparison between the analysis crack pattern and the expected one

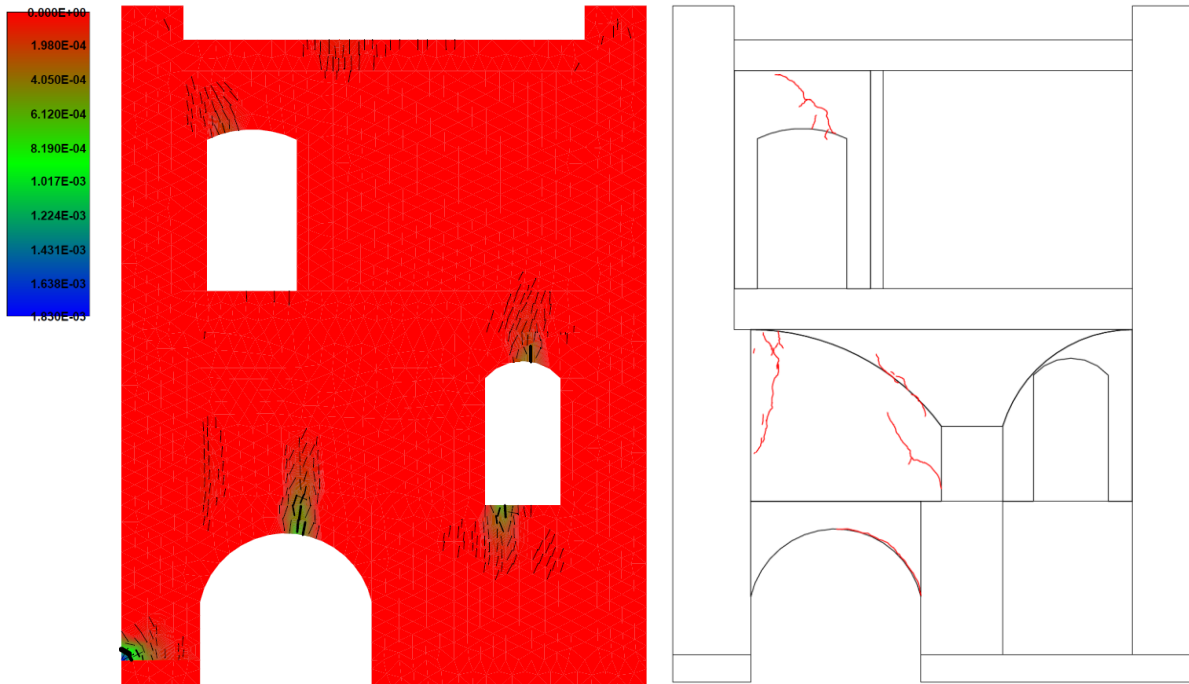
Figure 6.22 - Comparison between the analysis crack pattern and the expected one (m)

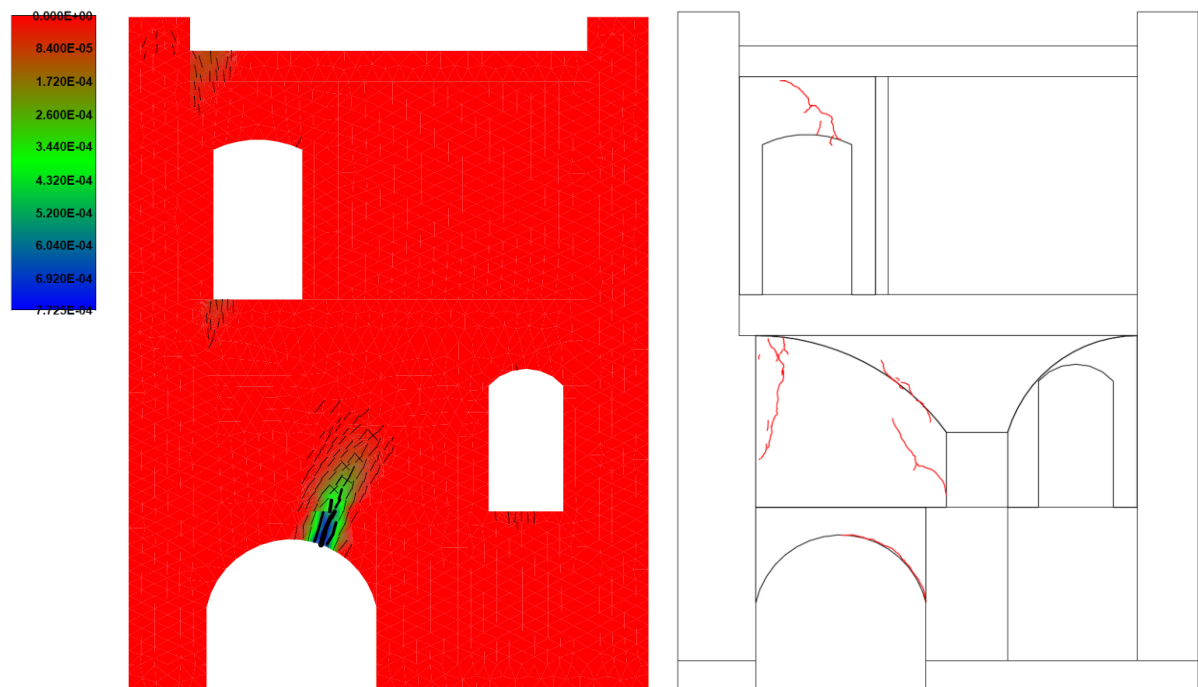
Figure 6.24 - Comparison between the analysis crack pattern and the expected one (m)

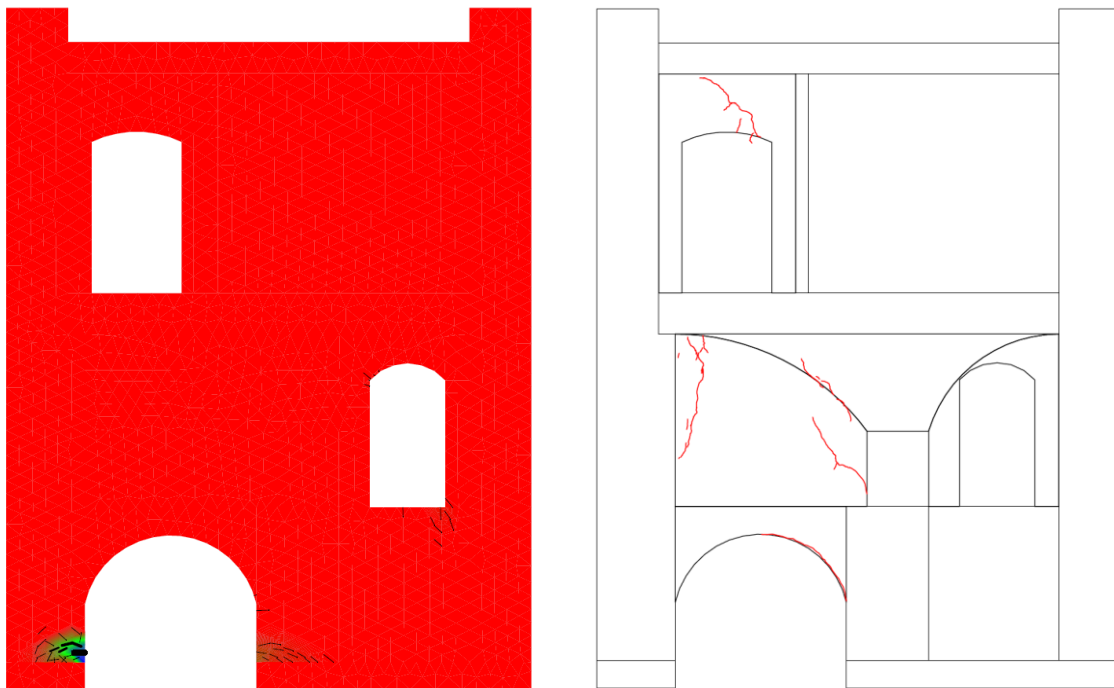
Figure 6.27 - Comparison between the analysis crack pattern and the expected one (m)

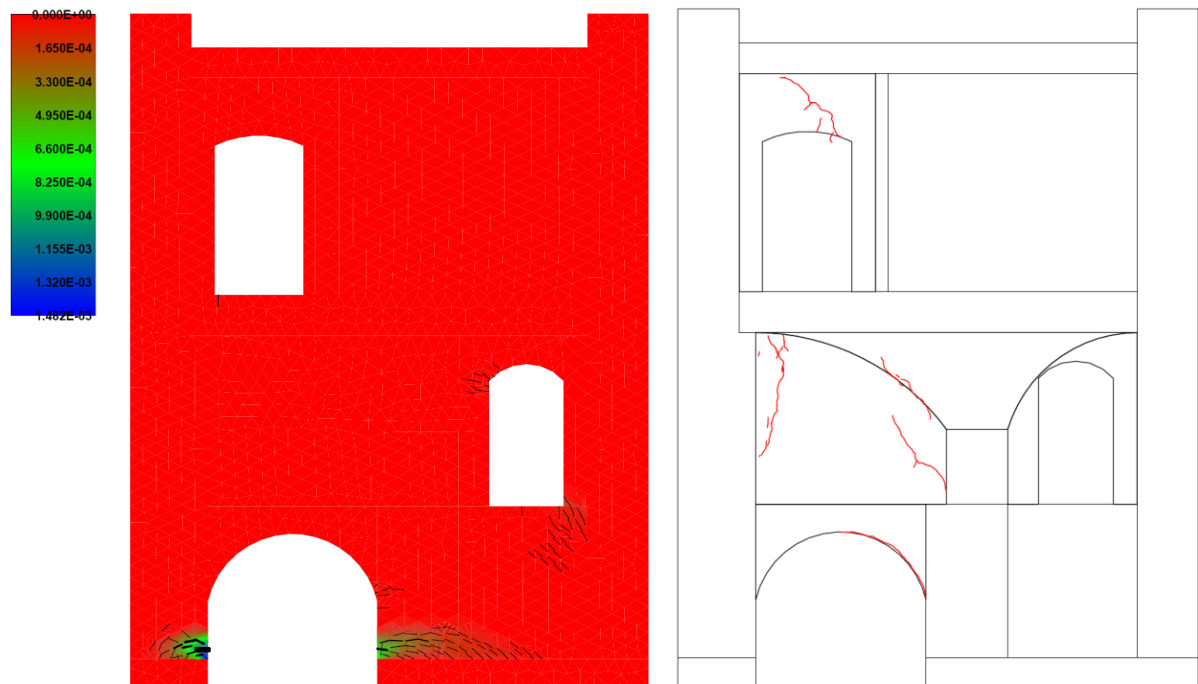
Figure 6.29 - Comparison between the analysis crack pattern and the expected one (m)
