# Evaluation of the Broumov parish house failure, its causality, and some ideas of remediation

*Structural Analysis of Monuments and Historical Constructions (SAHC) Master's Thesis*

*Czech Technical University in Prague*

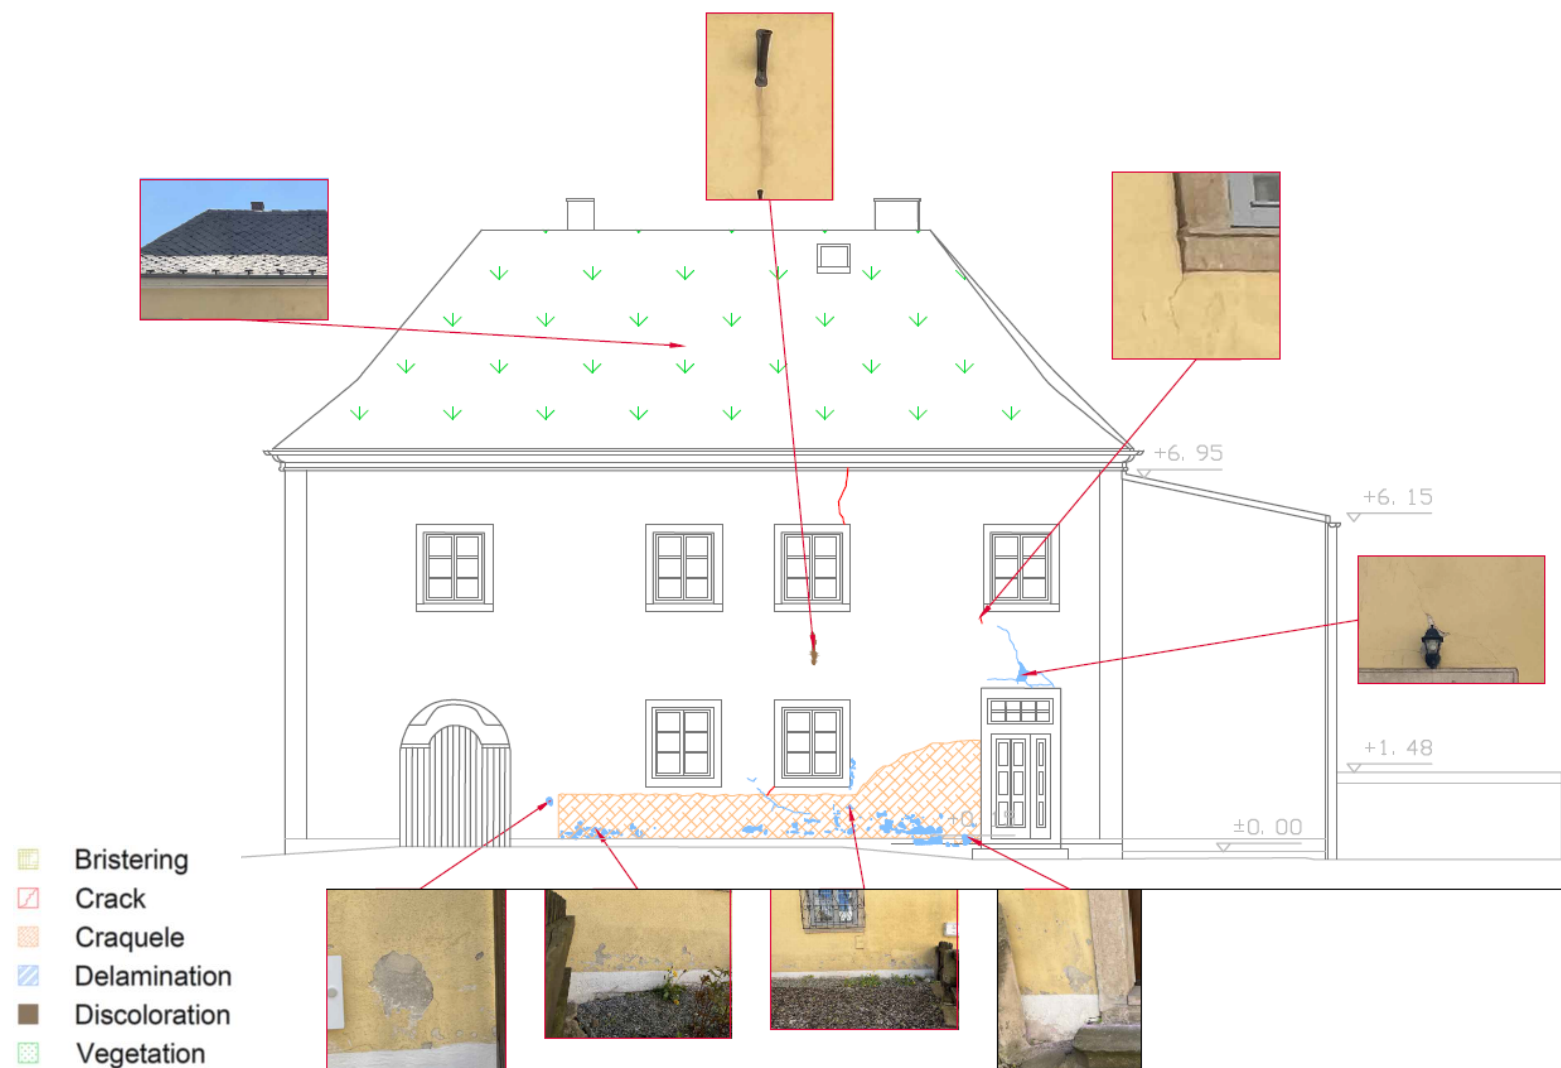
# Northeast Façade – Main Façade

The decay is **limited** to the superficial layer of **plaster** and has **not affected** the underlying **structural elements**.

- ***Crack monitoring and testing:***
  - electronic **crack monitors**.
  - crack endoscopy tests for the nature and severity of the cracks.
- ***Soil monitoring***, after investigating its mechanical parameters and the existence of foundation
- ***Moisture detection and evaluation*** using thermal cameras.
- ***Roof's condition evaluation:***
  - **leak tests** to identify areas where water penetration might occur.
  - the **main elements** should be **tested** to ensure the stability of the structure.
- ***Further investigation of the fresco's room condition:***
  - **cracks** on the ceiling and corners of the room.
  - thoroughly **test** the fresco room for **moisture**.
- The most immediate action that can take place promptly is the ***re-plastering of the exterior walls***.

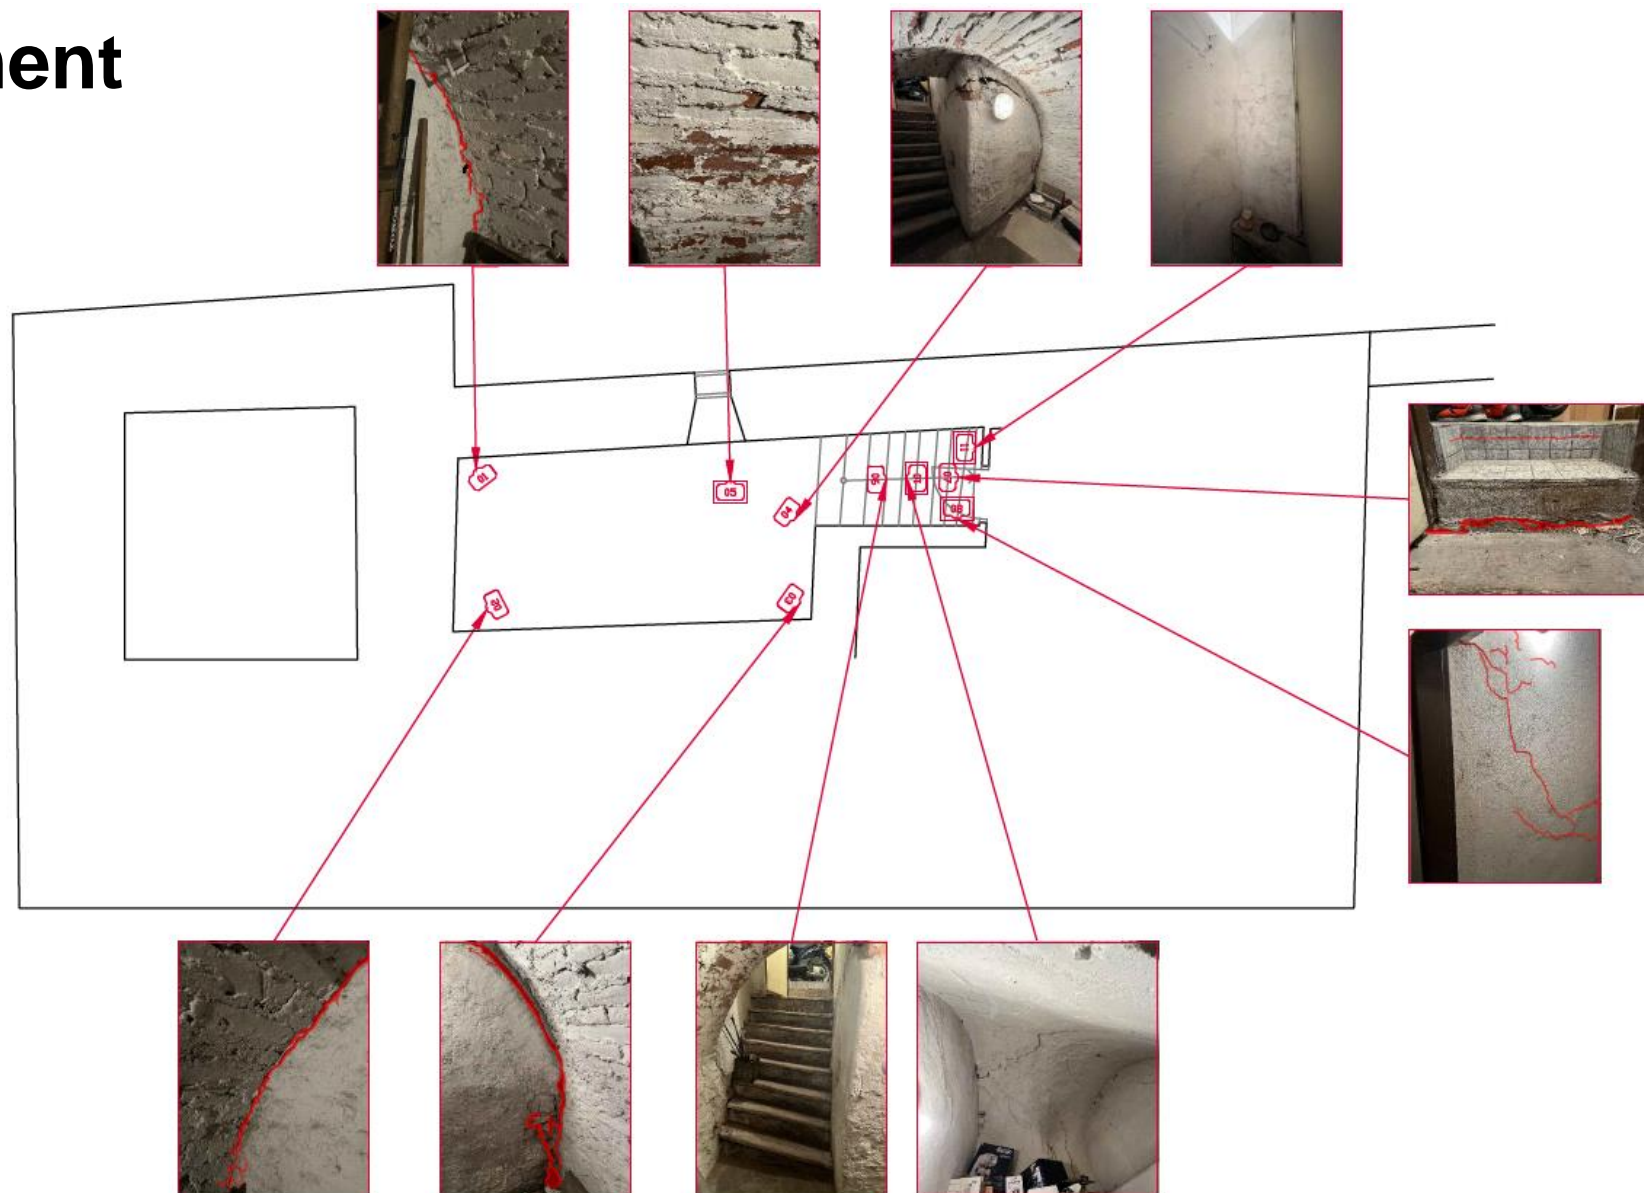
# Basement

- Fractures along the walls of most rooms, especially the middle wall of the main section.
  - Potential cause → ground deformations.
- Extensive moisture on the first floor.
  - Potential cause → roof problems.
