ADVANCED MASTERS IN STRUCTURAL ANALYSIS OF MONUMENTS AND HISTORICAL CONSTRUCTIONS

Master 's Thesis

Evaluation of the Broumov parish house failure, its casualty, and some ideas of remedation

University of Minho

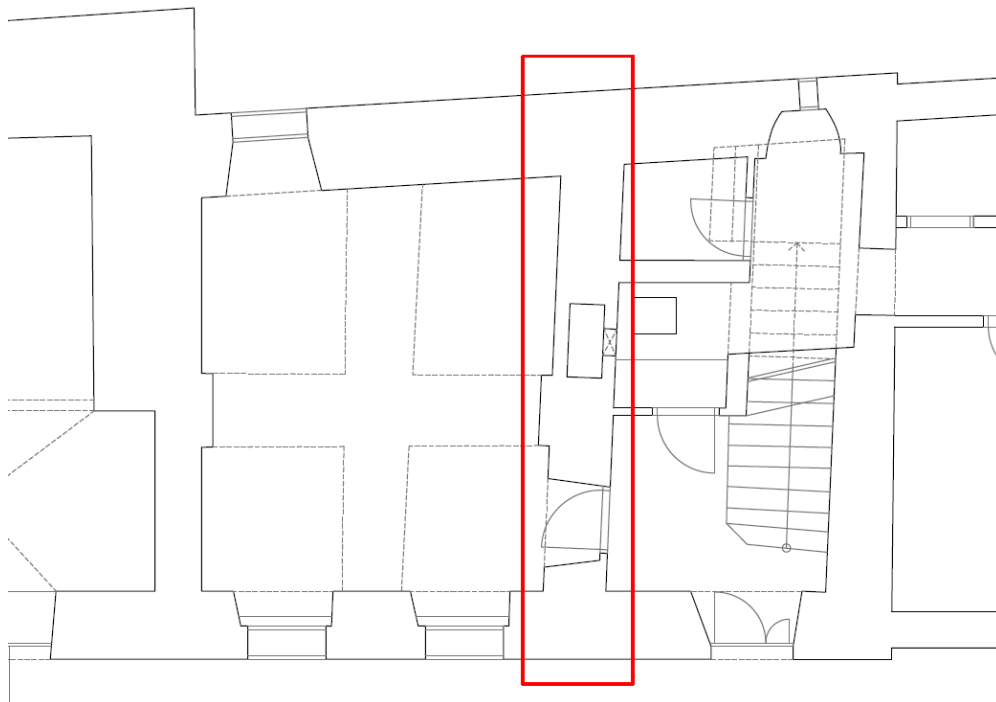
Figure 4.6 - Middle wall

Within the interior of the building, two primary types of decay are observed. The first type is fractures that as it is depicted in Figure 4.7 are concentrated along the middle wall of the main section of the building (Figure 4.6). A particular concern is the basement, where part of a wall has become detached, and the staircase within the basement area has become inclined. The reason is assumed to be potential ground deformations.

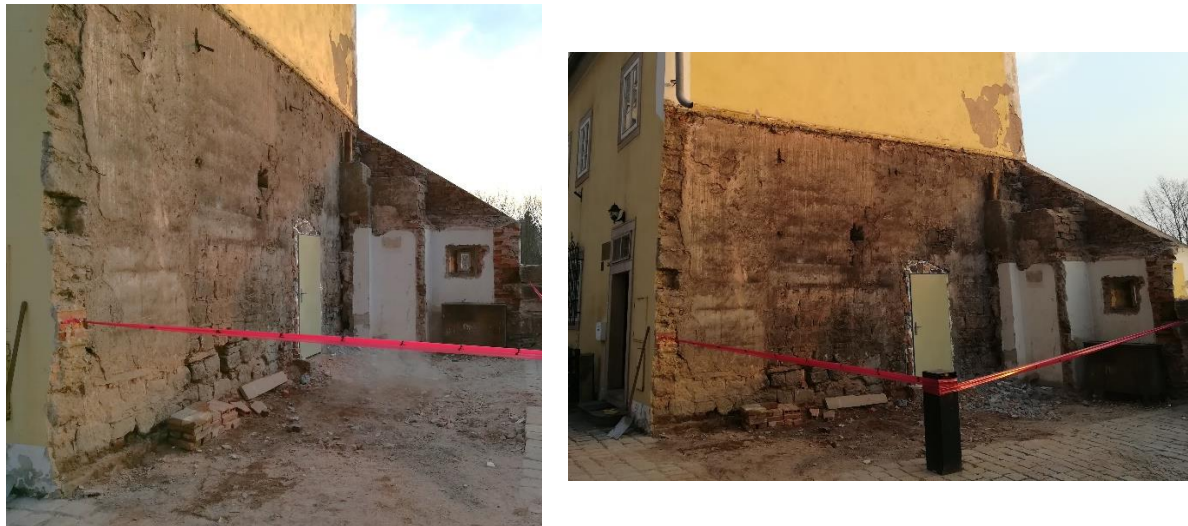
Figure 6.3 - Uncovered wall

Due to the complete plaster coverage of the walls throughout the building, conducting the MQI was challenging. However, P. ThLic. Martin Lanži was able to provide some photographs of the building during the demolition of the newest section, revealing the exposed masonry that was used for the evaluation of the wall.
